4.3 Fremont County

4.3.1 Double Dick Vicinity Mine

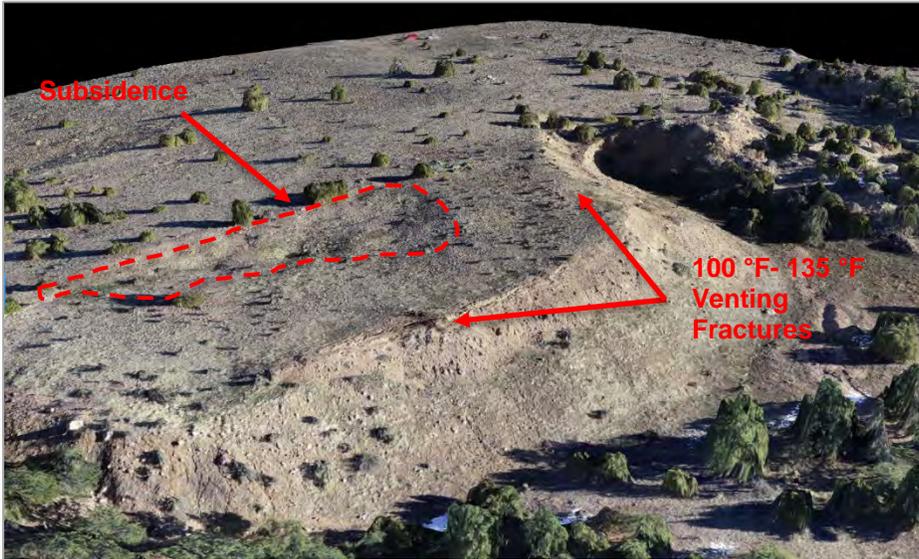
Figure 4-16 – 3D Model of Double Dick Vicinity Mine Fire Looking Northeast

There are two unrelated fire features at the site: one is a trench originally used to cut off the burning coal seam; the other is a coal waste pile that has been in some form of combustion since the 1980s as well.

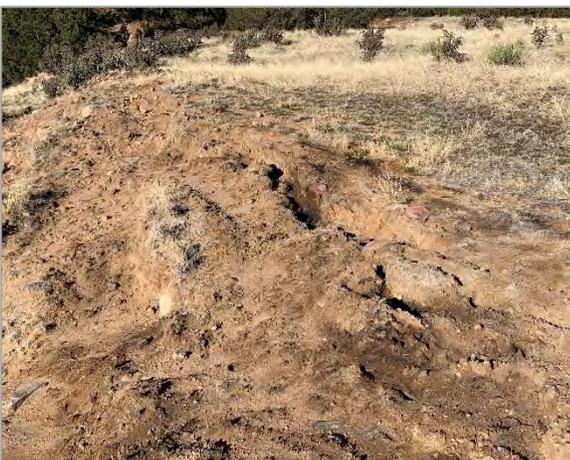
Figure 4-17 – Venting Fractures

Side in the 2005 Inventory Report) revealed numerous small cracks along the southern edge of the pile. These cracks were stained dark black and were emitting steam and some H₂S at low levels. The temperatures recorded in approximately 15-20 individual cracks ranged from 100-135°F. Additionally, vegetation within the immediate proximity to the vents was absent (Figure 4-17).

Mitigation of the waste pile would be recommended should the elevated temperatures persist through additional monitoring.
